# NAVAL FACILITIES ENGINEERING SERVICE CENTER Port Hueneme, California 93043-4370

# Technical Memorandum TM-2308-SHR

## **TEST REPORT OF MEDIA PROTECTION SYSTEMS**

Jan 21, 1999

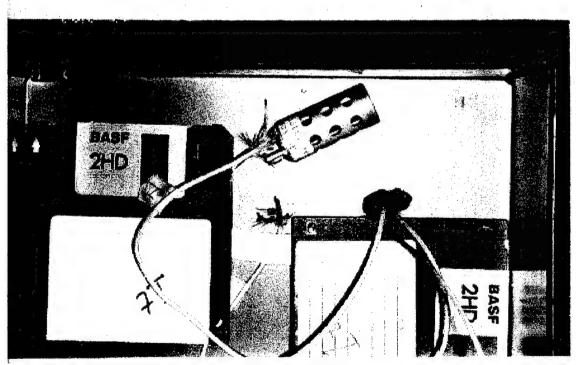
Photograph 1

Fire-resistant computer media containers are now available as commercial-off-the-shelf (COTS) products. These containers are called media protection systems (MPS) and are designed to insulate computer media against most structural fires. They utilize a relatively new technology called gaseous protection systems. When a MPS container is exposed to intense heat, the container cools itself by a process called ablative sublimation. Some MPS containers are small enough to fit within legal-size GSA-approved security file cabinets (Photo 1).

Description	Photo
GSA approved Class 6 security file cabinets (legal-size) prior to fire exposure.	1
Humidity sensor installed in test specimen.	. 2
Security file cabinets heated to a red incandescence.	3
Sentry 1710 enclosed in a ceramic soft-sided box after fire exposure.	4
Sentry 1710 prior to fire exposure.	5
Fire Cooler 1000 prior to fire exposure.	6
Fire Cooler 1000 after fire exposure.	7
Fire Cooler 1100 after fire exposure.	8
Media Cooler after fire exposure.	.9
Transformer 125T prior to fire exposure.	10
Transformer 125H prior to fire exposure.	11
Downey Box prior to fire exposure.	12
Albacore Box prior to fire exposure.	13
Albacore Box after fire exposure.	14

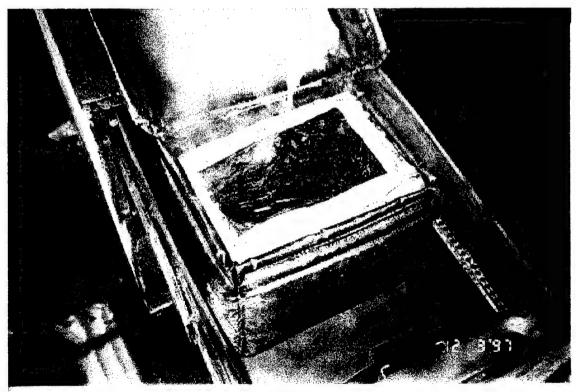
Photograph 4

- a) <u>Sentry 1710 (enclosed with a Ceramic Soft Box)</u> This product, when enclosed in the specially fabricated Ceramic Soft Box, protected the electronic media. The floppy disks were undamaged and readable after the fire exposure (Photo 4).

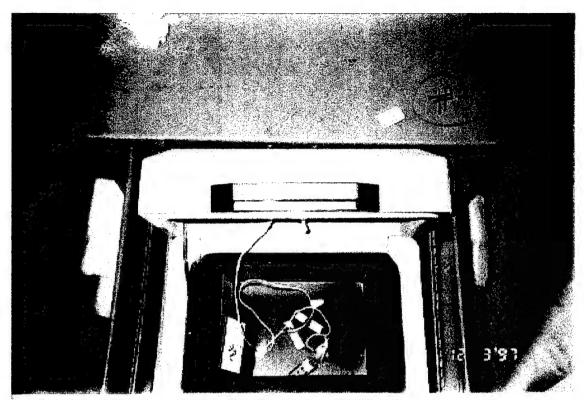
Photograph 5

- b) <u>Sentry 1710 (without the Ceramic Soft Box)</u> This product (Photo 5) did not protect the enclosed floppy disks. The disks and the test specimen were destroyed.

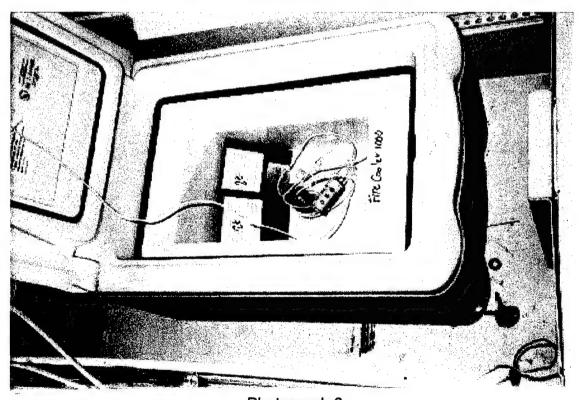
Photograph 6

- d) <u>Fire Cooler 1000</u> This product (Photo 6) did protect the enclosed floppy disks. They were fully functional and the data on the floppy disks were readable after the exposure (Photo 7).

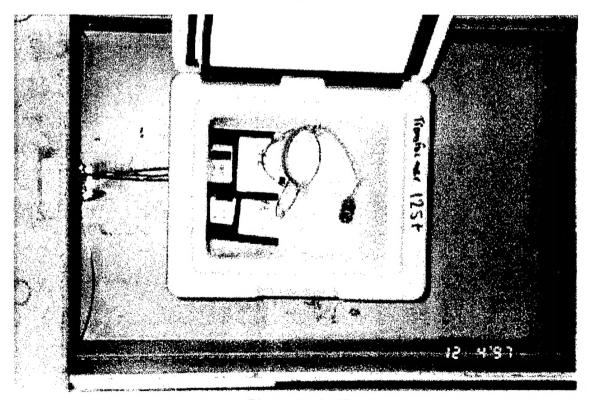
Photograph 9

- f) Media Cooler This product did not protect the enclosed disks. The disks and the test specimen were destroyed (Photo 9).

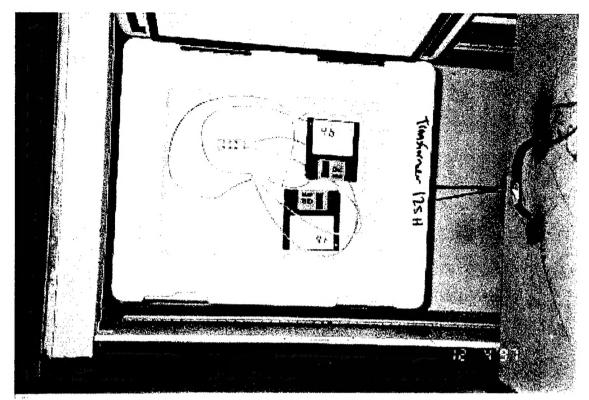
Photograph 11

- b) <u>Transformer 125H</u> This product (Photo 11) failed the test. Thermocouples indicate the interior temperature exceeded the Class 125 limit after approximately 30 minutes of exposure, climbing to over 750 degrees before the furnace was extinguished. The relative humidity level was not measured due to sensor failure. The floppy disks and the test specimen were destroyed.

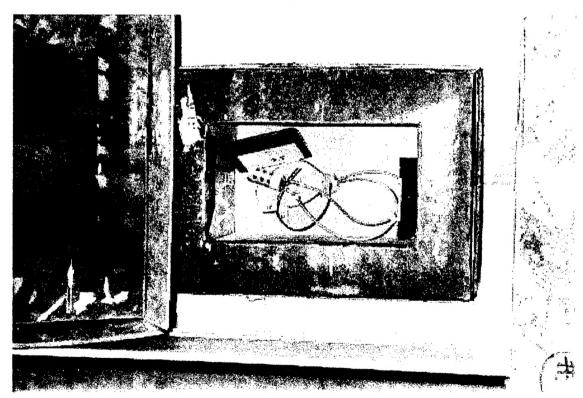
Photograph 12

- c) <u>Downey Box</u> This product (Photo 12) failed the test. Thermocouple data in both the Downey Box specimens indicate the interior temperature exceeded Class 125 limits after approximately 18 minutes of exposure, and climbed to approximately 250 degrees before the furnace was extinguished. The relative humidity level remained at about 82 percent. The floppy disks were warped and unusable and the test specimen was destroyed.

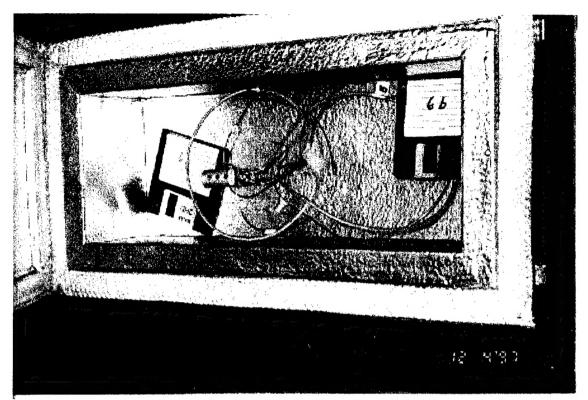
Photograph 13

- d) Albacore Box This product (Photo 13) failed the test. Thermocouple data in both the Albacore Box specimens indicate the interior temperature exceeded 125 degrees (Class 125 test limit) after approximately 21 minutes of exposure, and climbed to approximately 300 degrees before the furnace was extinguished. The relative humidity sensor for the specimen in the top drawer failed. The sensor in the bottom specimen indicated about 83 percent relative humidity. The floppy disks and test specimen were destroyed (Photo 14).
